LANL's Stormwater Management Projects and Protection of the Rio Grande

Presentation to the Sierra Club

Los Alamos National Laboratory
Environmental Programs Directorate

June 1, 2011

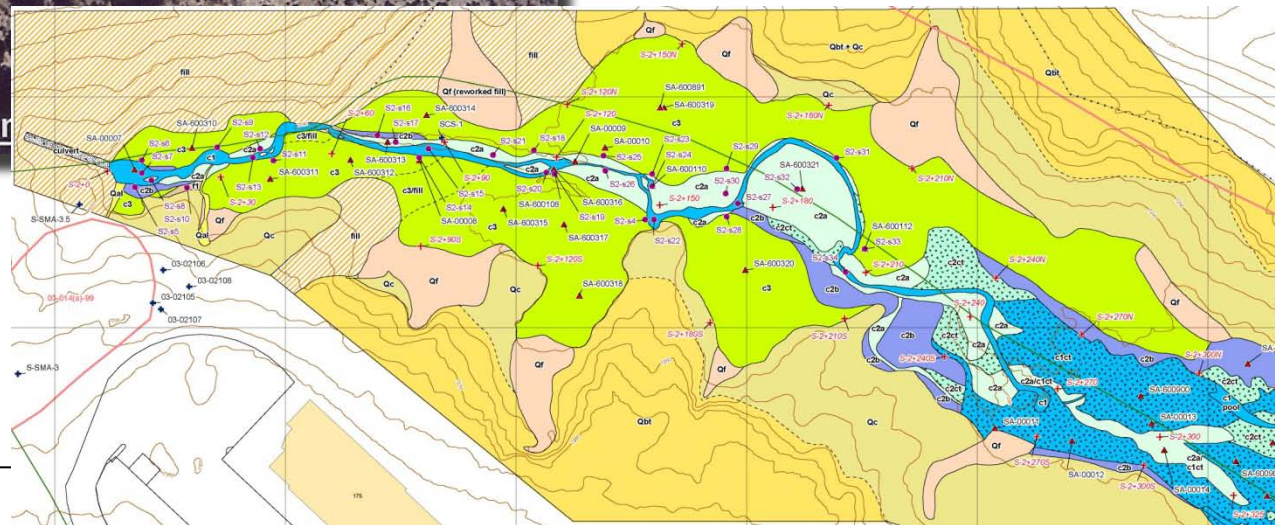
Photo Analysis

Geomorphic-based characterization

Conclusion: residual contamination is within target risk levels

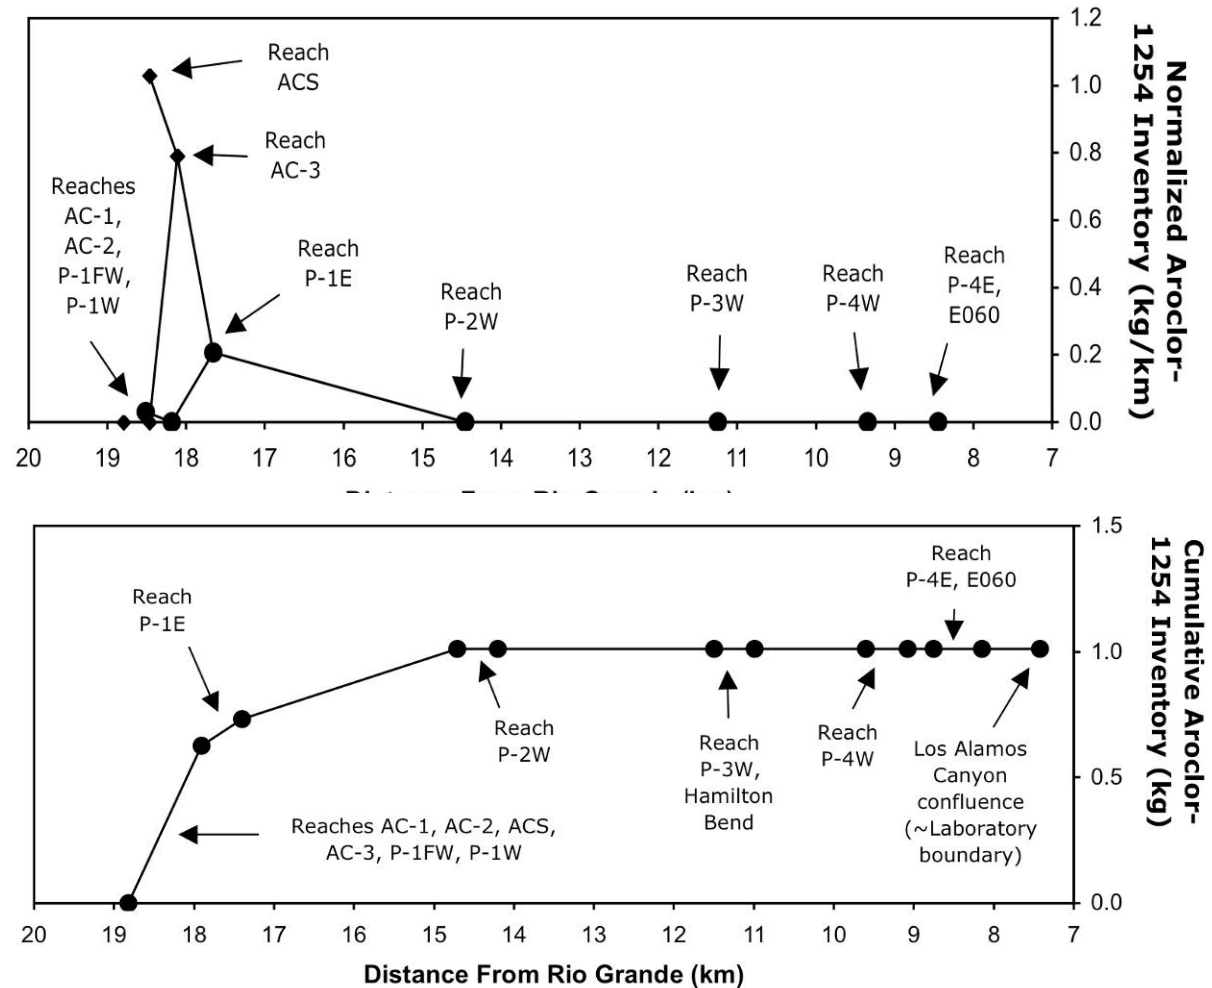
Conceptual Model

Inventory is near original source

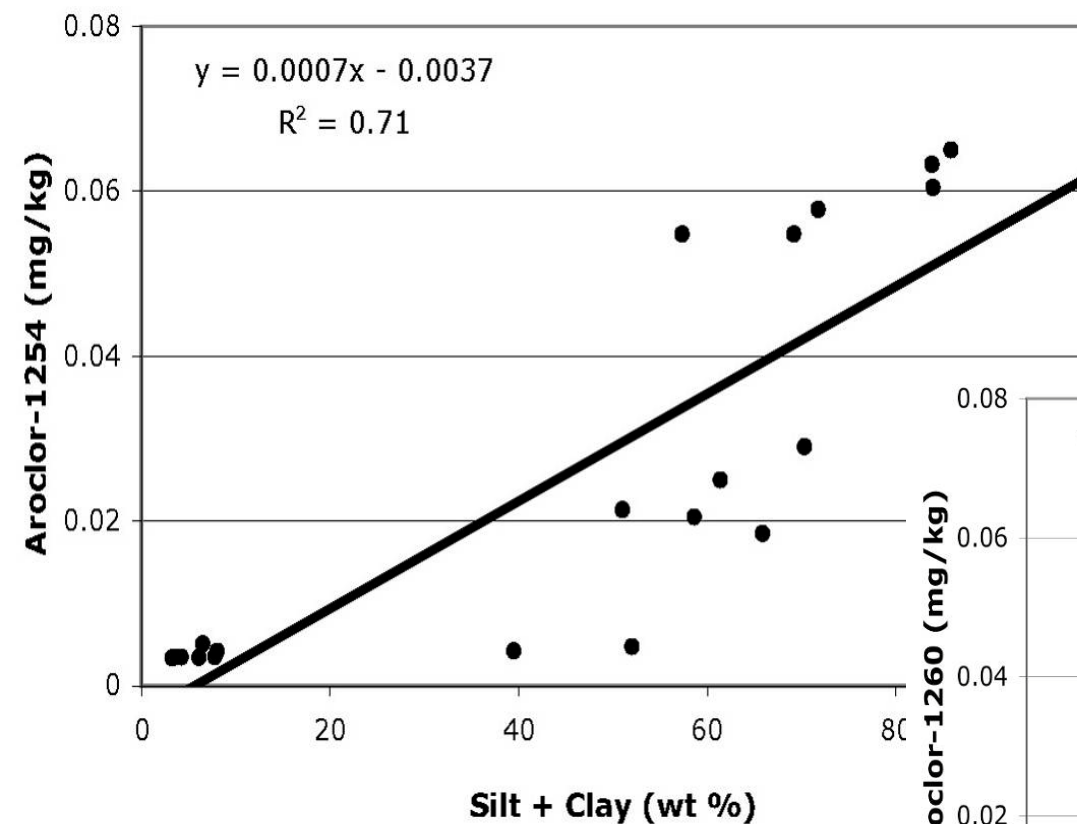
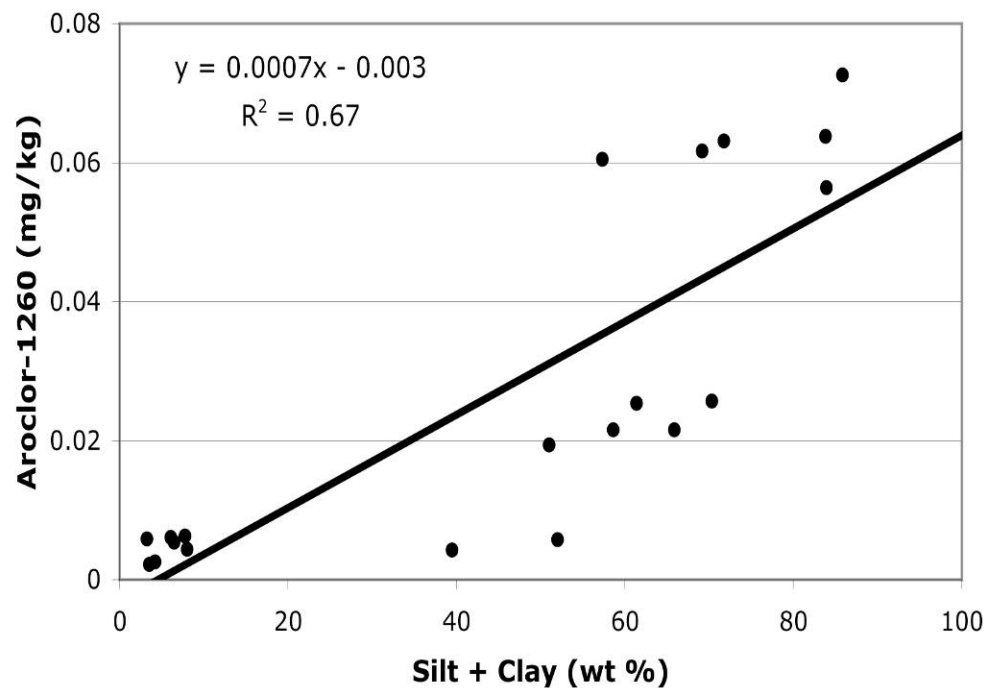
Conceptual Model (cont.)

Contaminant concentration related to fine-grained particles

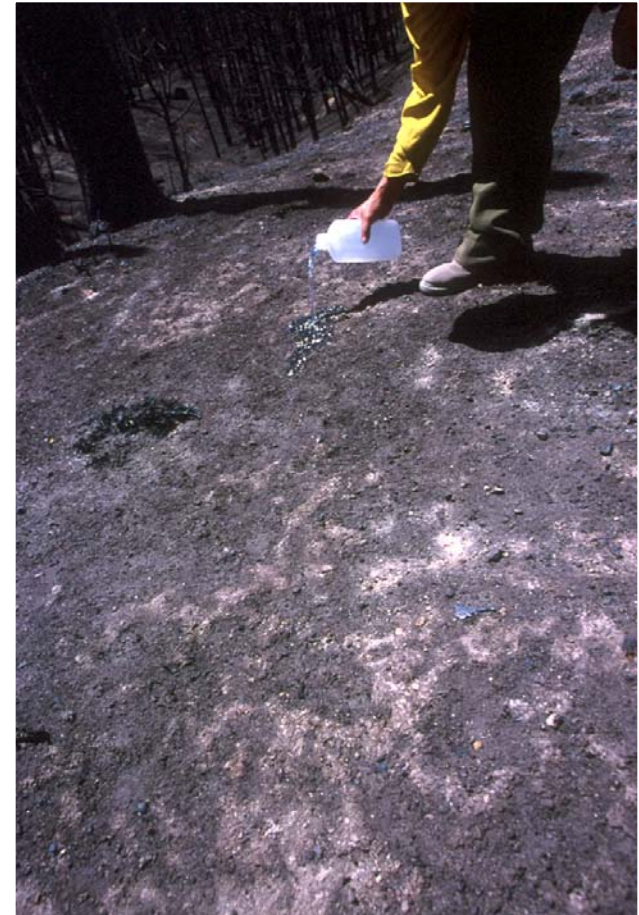
- ❖ Minor rainfall runoff prior to Cerro Grande fire
- ❖ Post-CG fire conditions created perturbation watershed hydrology = greater runoff

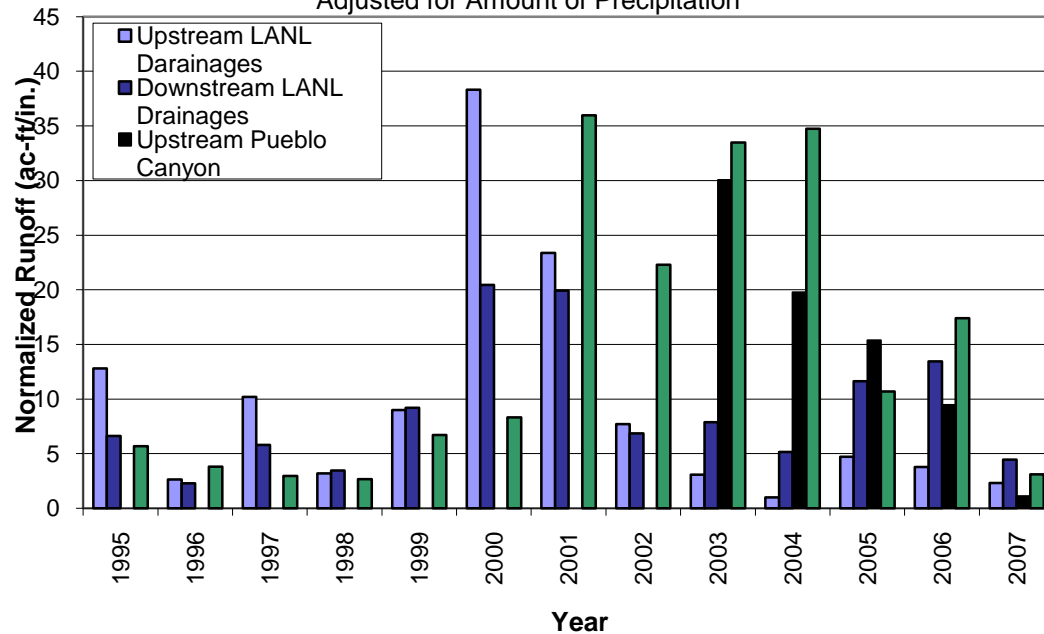
Summer Runoff Yields (June - Oct)
Adjusted for Amount of Precipitation

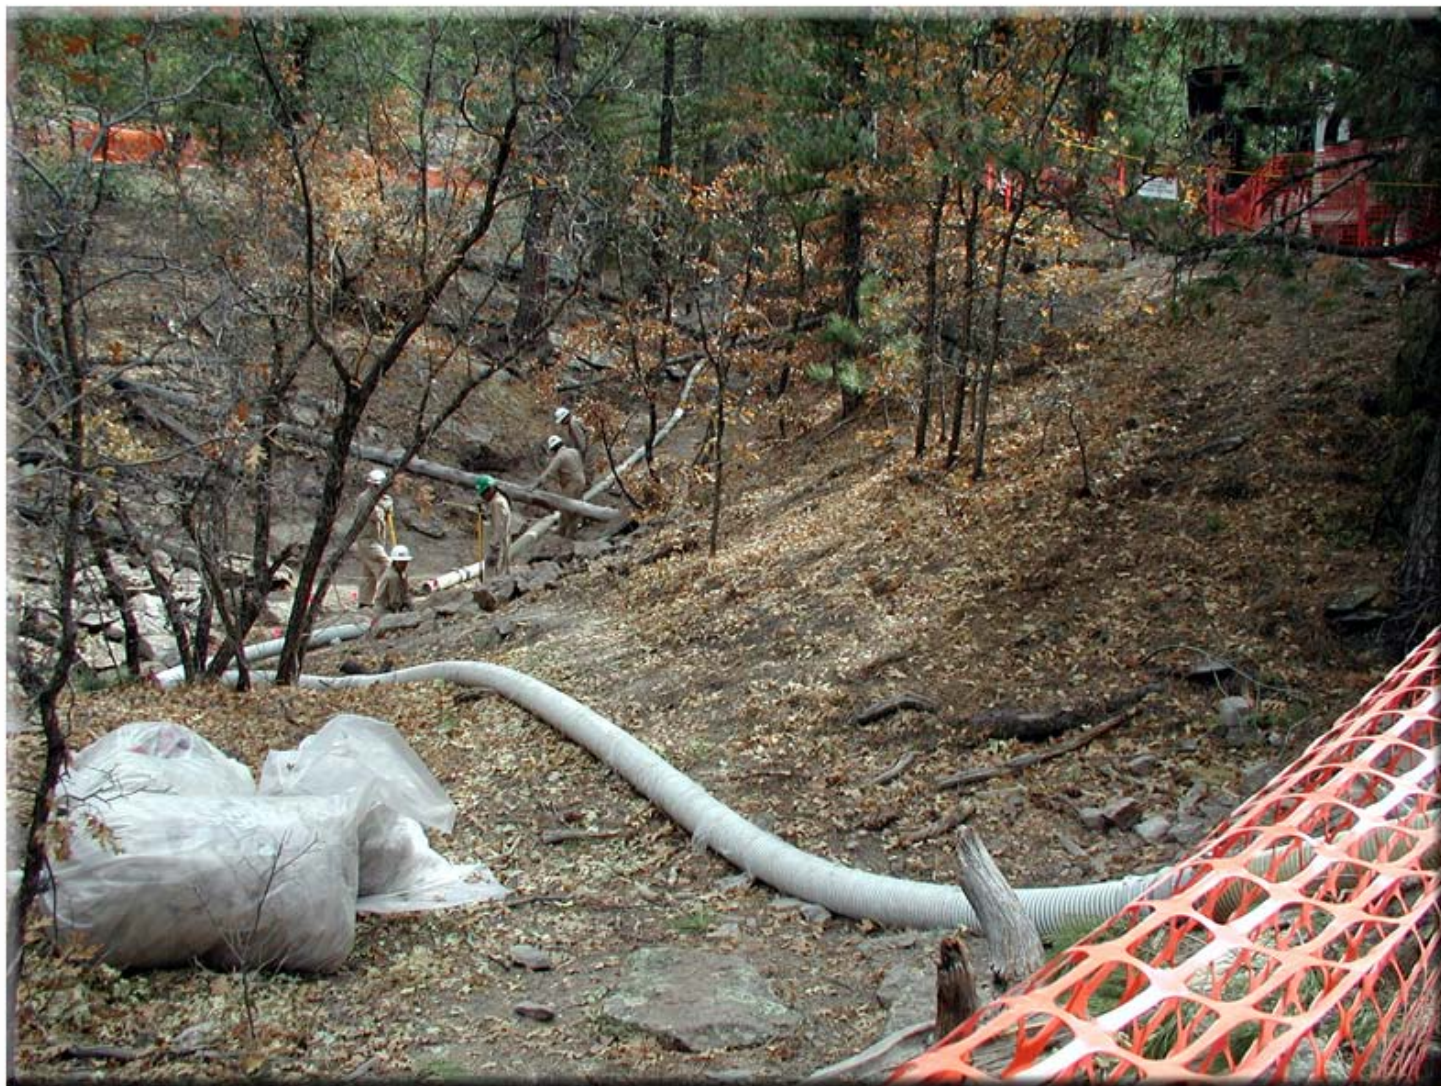
Targeted Contaminant Removal – Acid Canyon

Reduced watershed
inventory of Pu by
14%

Reduced exposure-
scenario dose by
50%

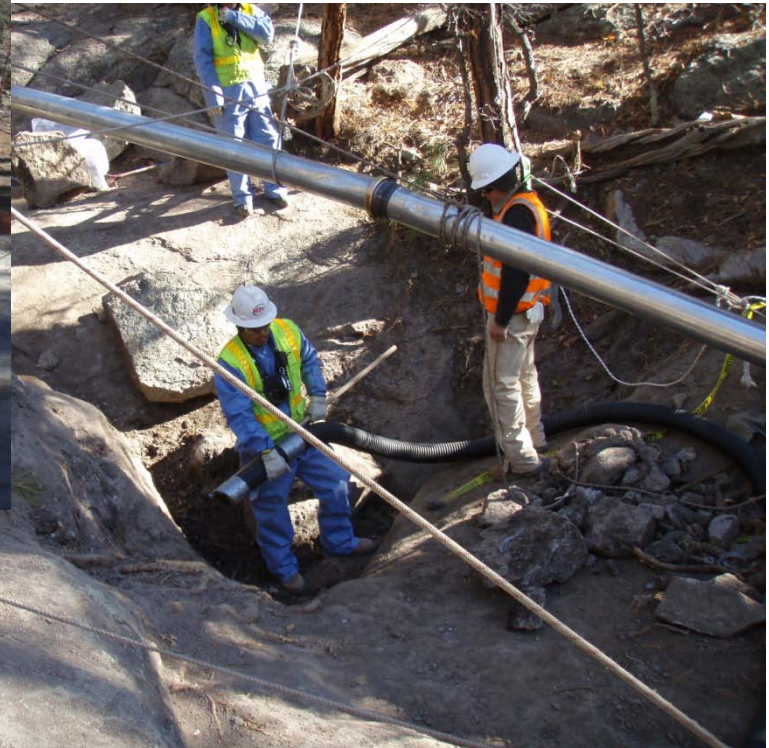
LA-SMA-2
Vacuum upper drainage sediments
Removal of >1,000 cu/yds

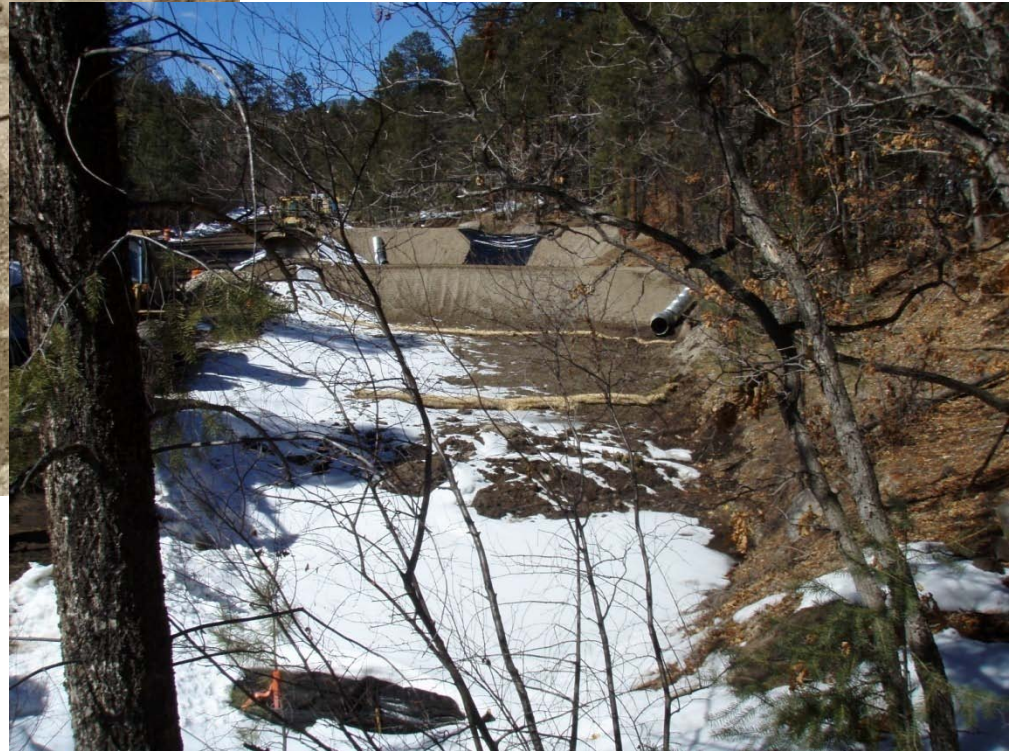
**LA-SMA -2 Detention Berms
Over 2,000 cu/yd removed**

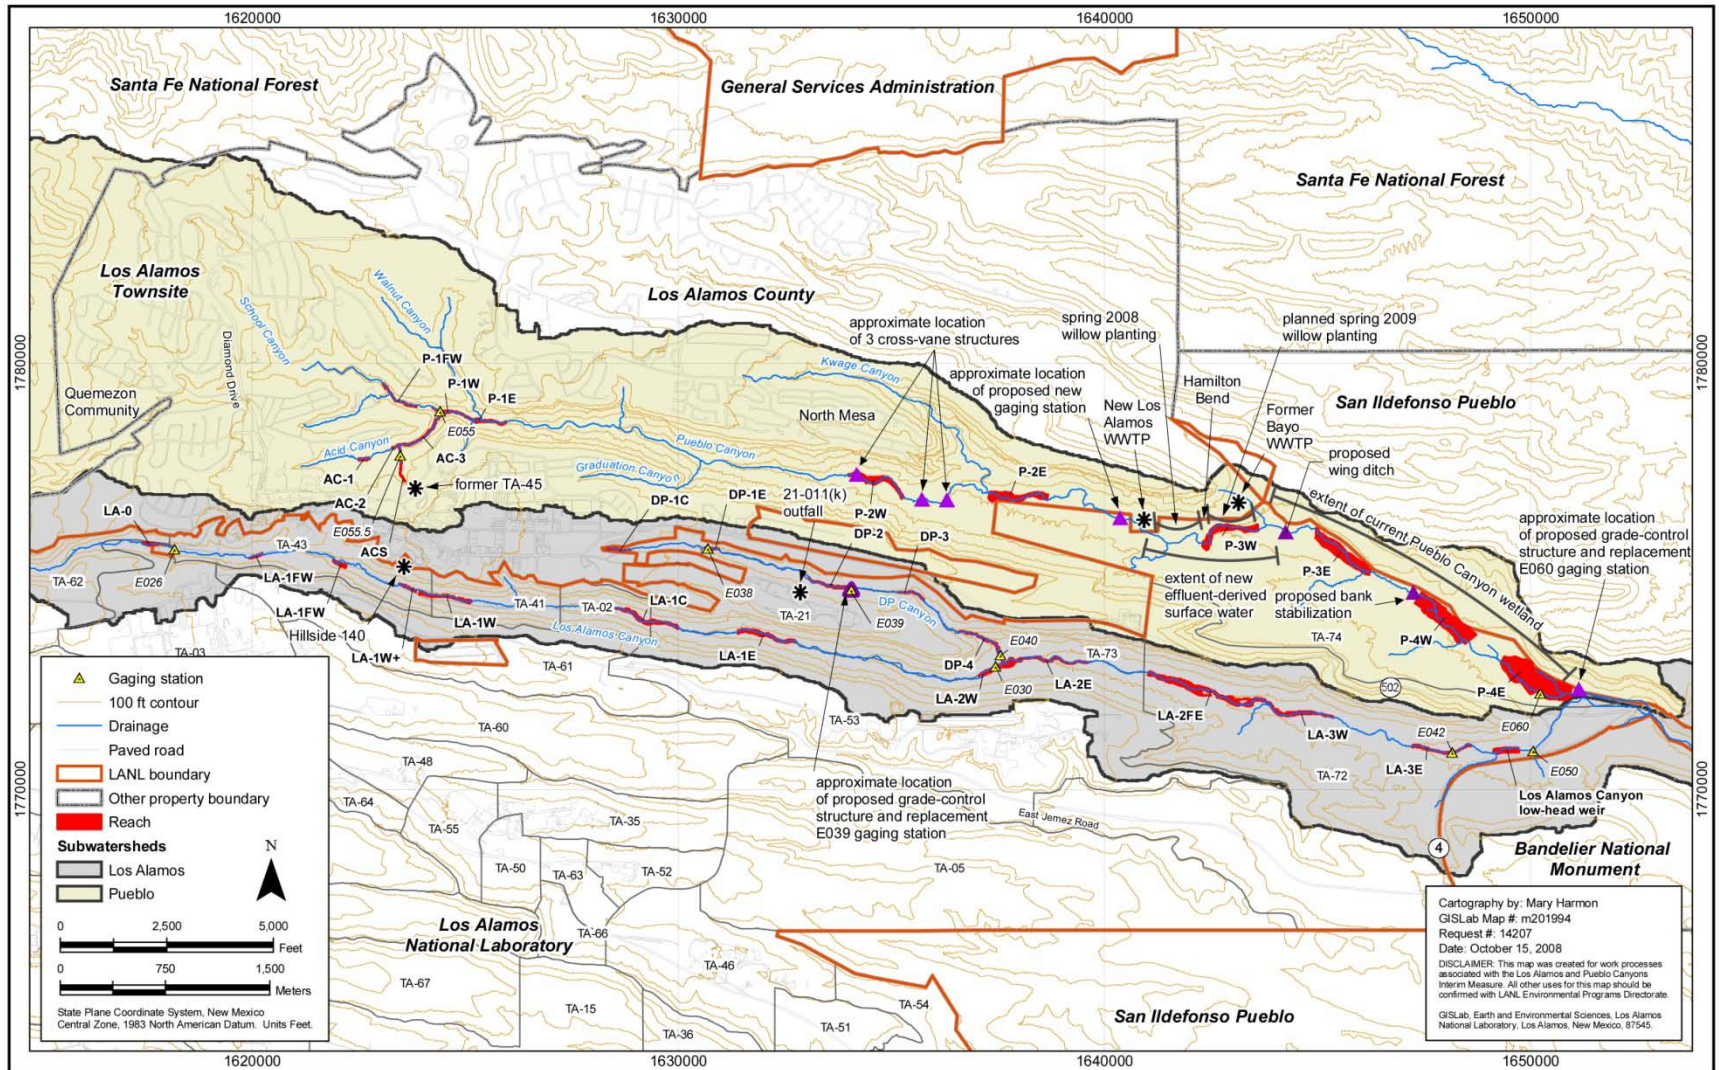
Los Alamos/Pueblo Watershed - Mitigations

Principle Actions Taken to Achieve Goals

Pueblo Canyon

- Willow planting
- Grade control structure

DP/Los Alamos Canyon

- Grade control structure
- Excavation/Enhancement of LA Weir

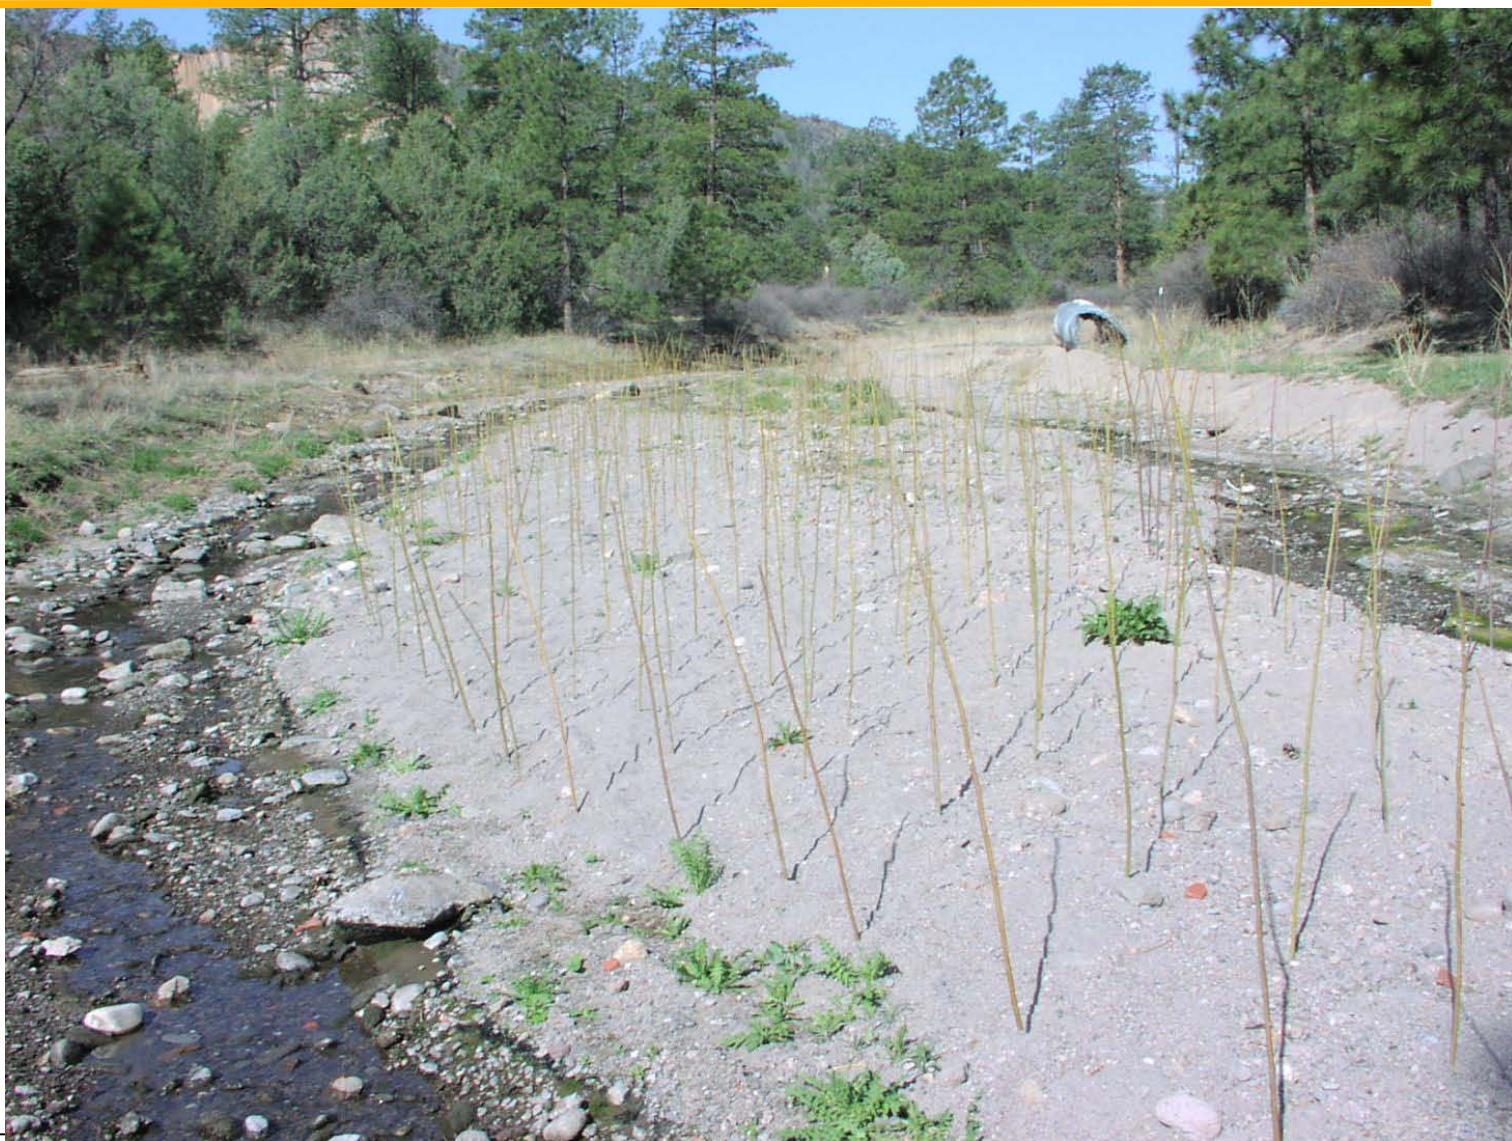
Mitigations Bank Stabilization – Willows (Spring 2009)

Approximately
6000 willow
poles planted
in Pueblo
Canyon during
Spring 2009

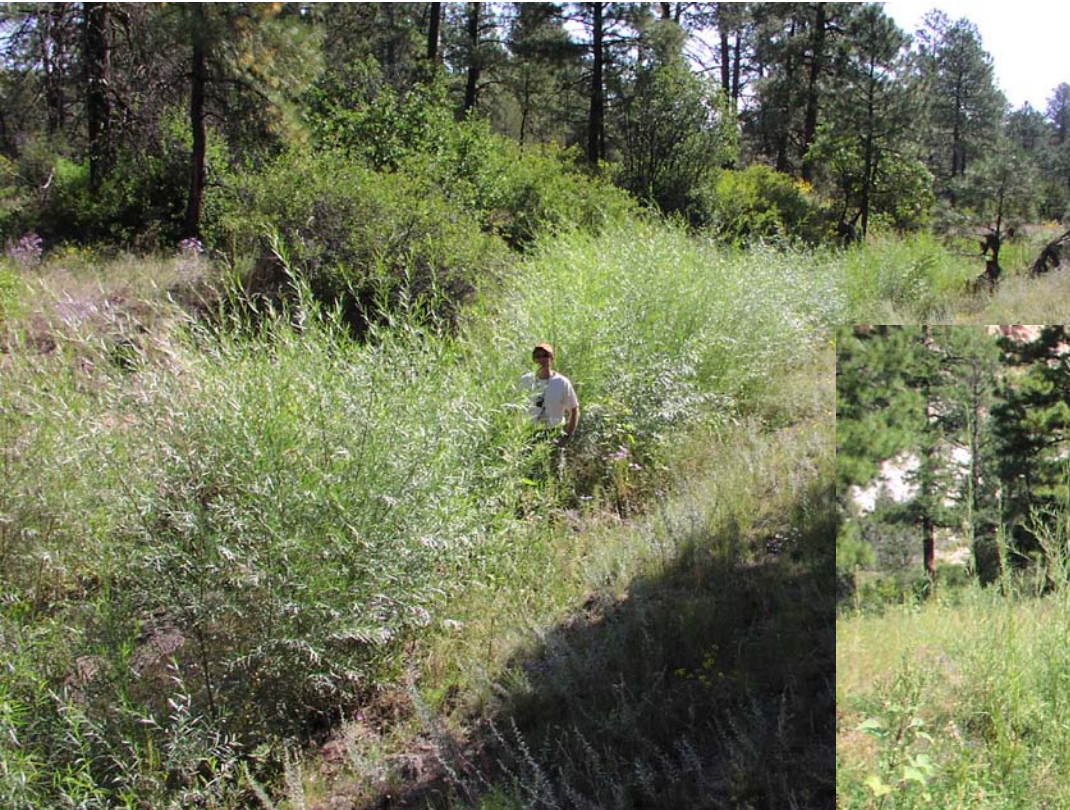
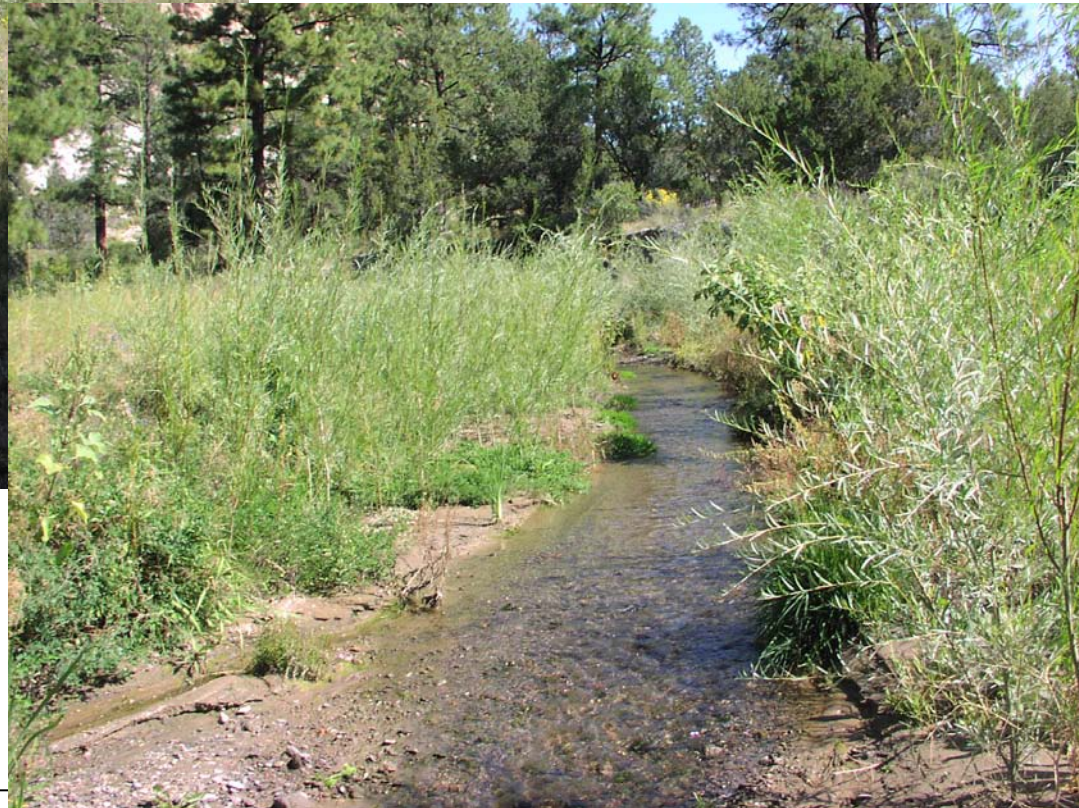
Bank Stabilization – Willows (Summer 2010)

Maintains bank stability,
reduces flood peaks,
traps sediment

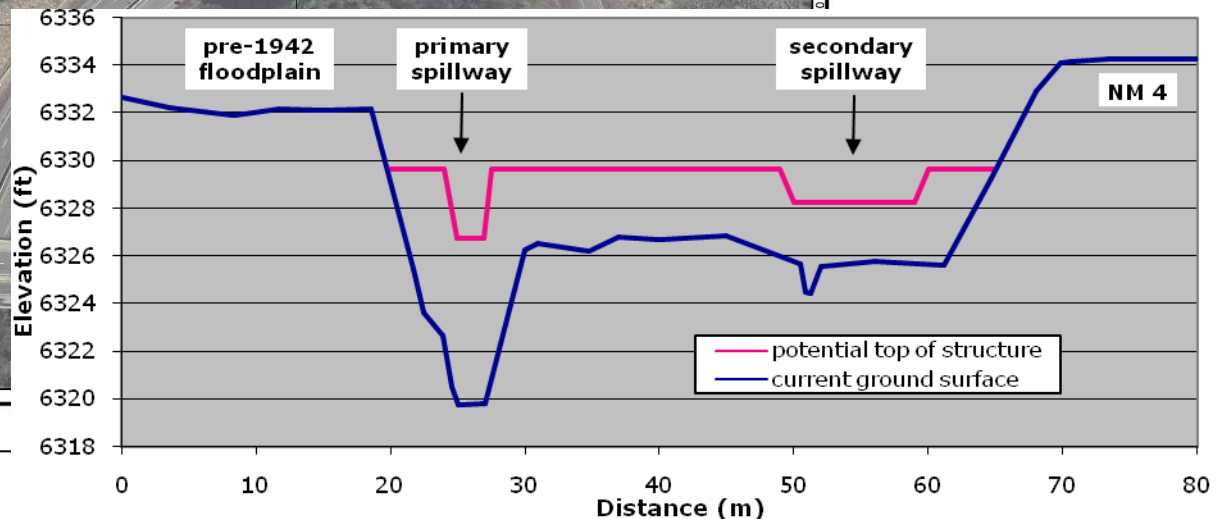
Conceptual grade-control structure

Extend and stabilize terminus of wetland

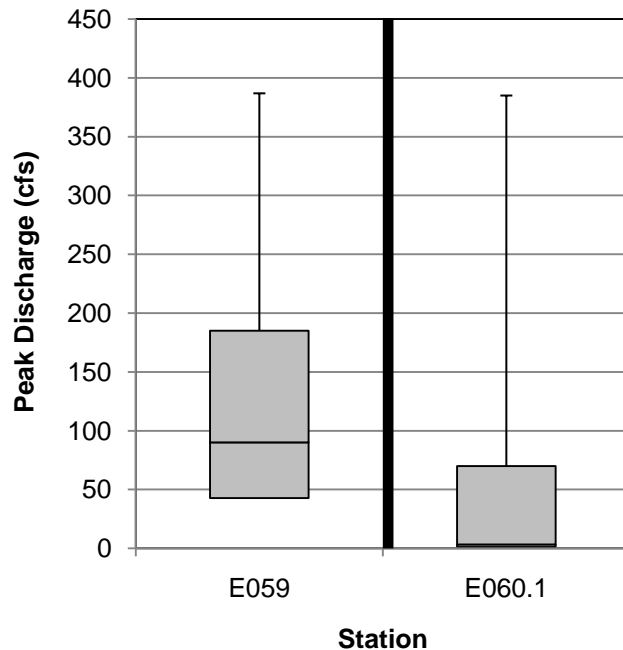
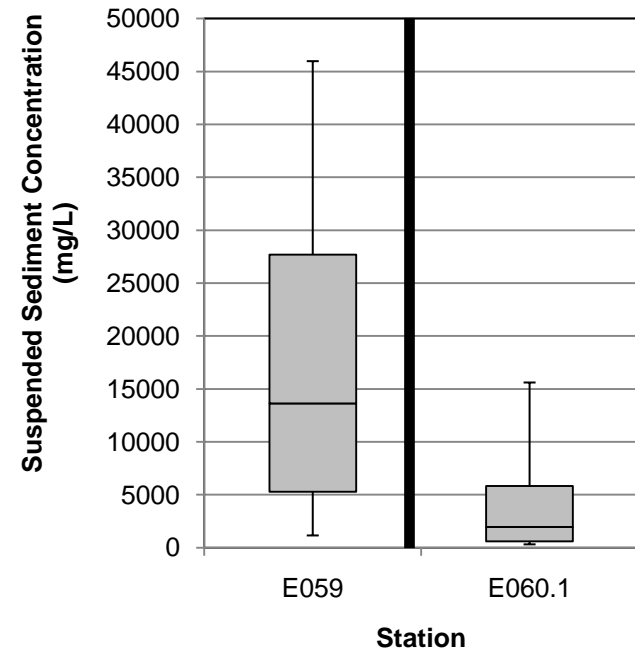
2010 Performance Monitoring Data – Lower Pueblo Canyon Wetland

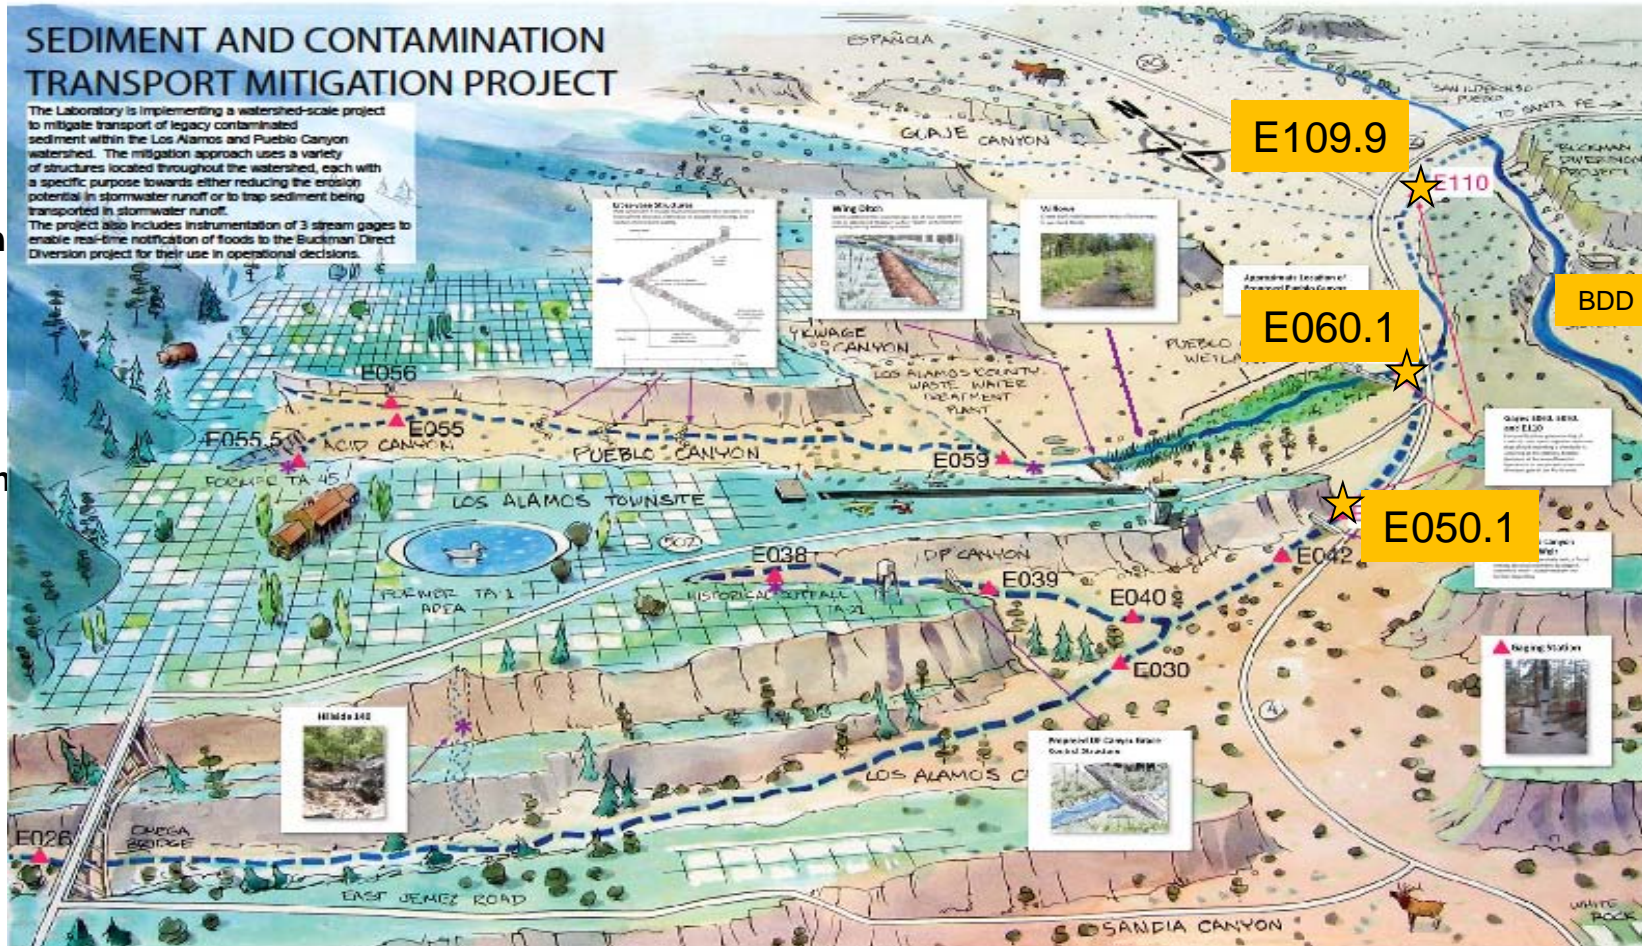
Early-Notification System

3 lower canyon gages (E050.1, E060.1 and E109.9)

Real-time communication of flow for Buckman

Water-quality data
